**STATE CAPITOL REHABILITATION AND
RENOVATION / CAPITOL SQUARE PROJECT**

**SERIES 2 - WYOMING STATE CAPITOL
SD OWNER REVIEW**

LEVEL III SCHEMATIC DESIGN REPORT
VOLUME I OF III

ASSESSMENT AND RECOMMENDATIONS

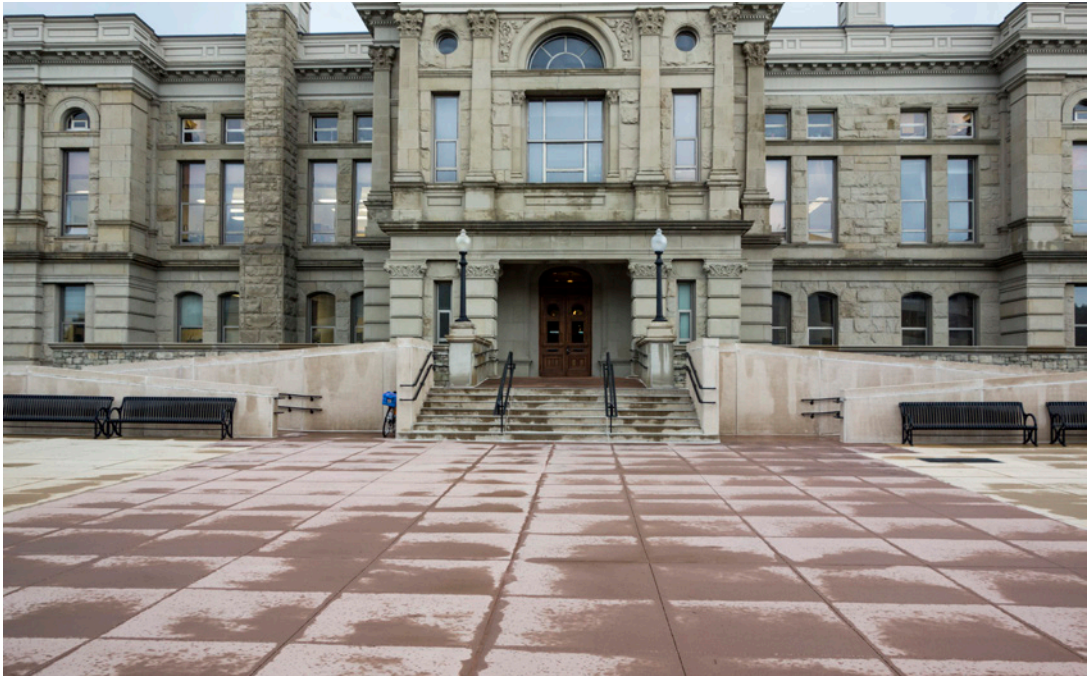
- The North Entrance Stairs were reconfigured in 2010 when the plaza north of the Capitol was redesigned [Figure 6.4.3.38]. The work included:
 - Removal of north exterior entrance stairs
 - Relocation of stone cheekwalls
 - Construction of new landing outside north entrance
 - Construction of new North Entrance stairs and handicapped ramps with high retaining walls.
- The reconfiguration of the North Stairs has altered the way in which the North Elevation relates to the landscape. The monumental character of this entrance has been eliminated.

Figure 6.4.3.38: View of North Entrance Stairs.

- Remove metal railings.
- Carefully remove existing cheek walls.
- Carefully disassemble stairs as required to remove cheek walls. Salvage stone treads for reuse. Protect and store stone units for repair and reassembly.
- Protect masonry support structure.
- Provide new metal railings with built-in lighting.
- Reconstruct cheek walls and reconstruct / reassemble stairs to match materials, configuration and design of historic North Stairs, accommodating proposed Connection to the Connector below with a reduced number of treads and risers.

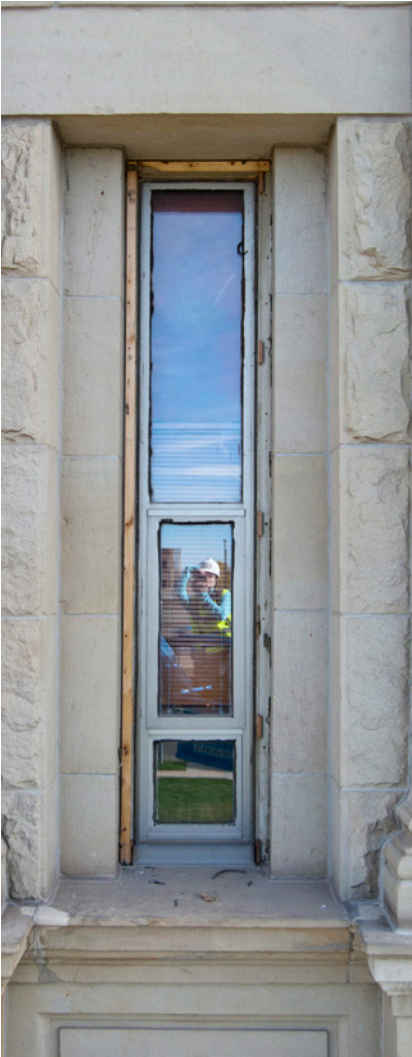
Figure 6.4.3.40: Window W271 with Historic Profiled Wood Frame Exposed on Right During Probe.

Replacement of nearly all the sash resulted in a significant change in the appearance of the building due to alteration in the visual rhythm of the muntins [Refer to Volume III A, Figure 17). The original single hung and double hung units were replaced with small hopper/awning units set in fixed lites: [Figure 6.4.3.39 and Figure 6.4.3.40]

- Remove aluminum replacement sash at all windows. Install new wood sash as follows:
 - For windows 5' or less in width, double-glazed wood sash constructed of finish-grade, old-growth, Long-leaf Yellow Pine, or old-growth Douglas Fir.

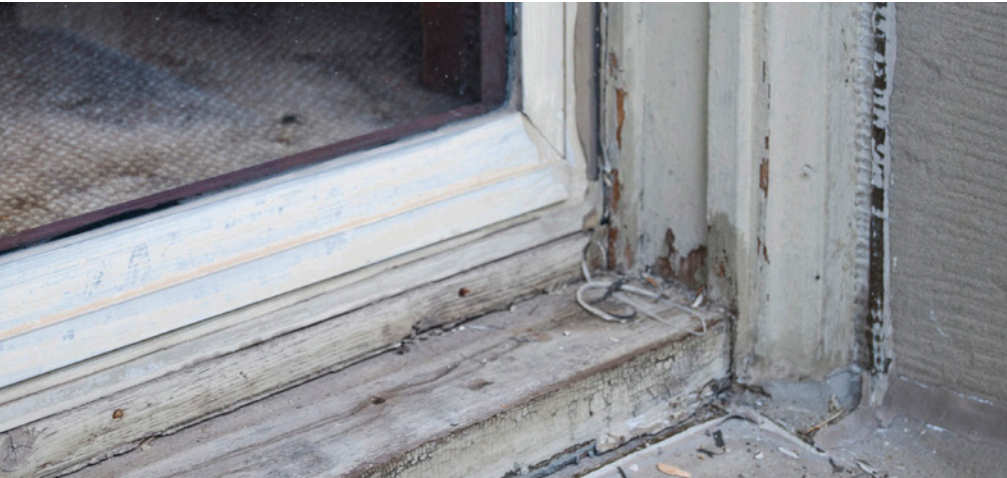
Figure 6.4.3.41: Window S309 with Wood Sill and Profiled Historic Wood Frame Exposed during Probe.

- Repair, recondition, and paint all wood window frames and sills. Assume 20% component replacement at exterior window frames, and 20% sill replacement.

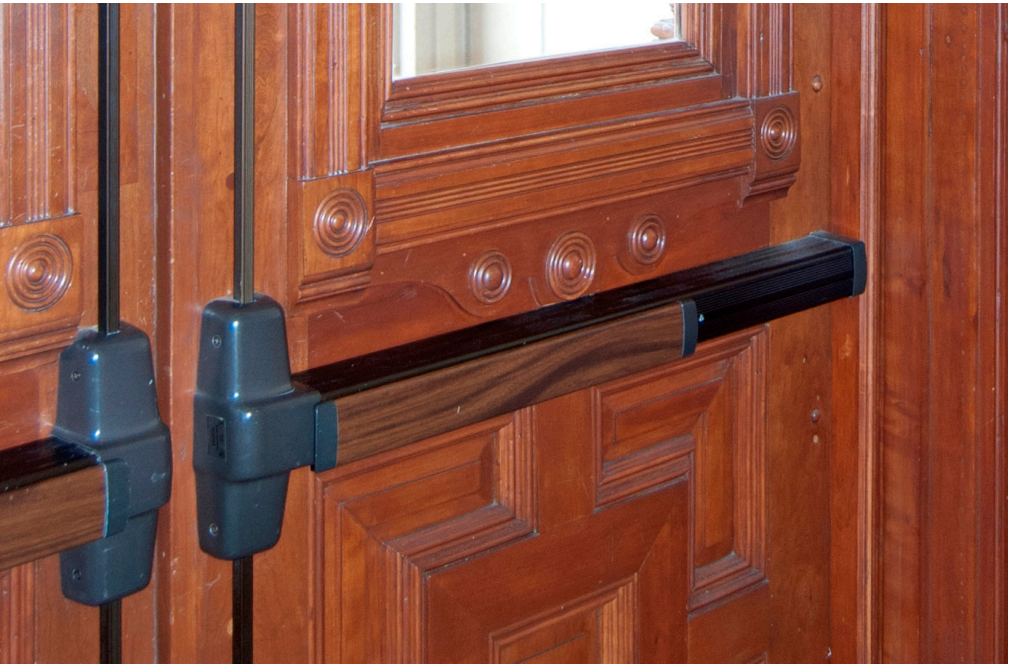
Figure 6.4.3.50: Existing Interior Exit Hardware Overlaps Historic Molding Profiles located on the Interior Face of the Exterior Doors.

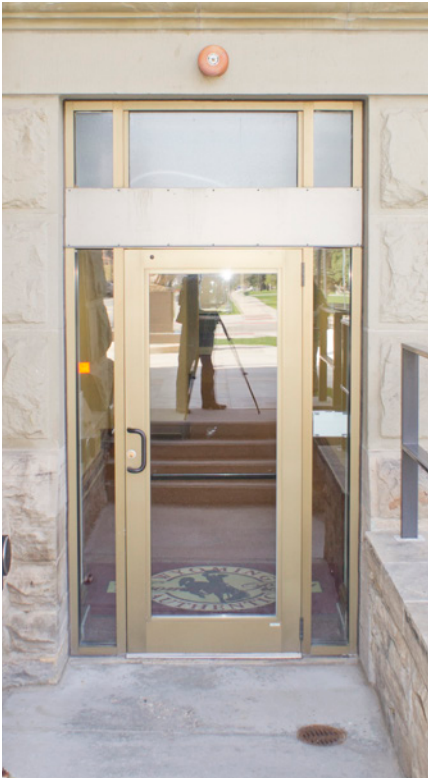
Figure 6.4.3.51: Garden Level Door B54-1 with Replacement 'Storefront' Door, Sidelights and Frame.

- All exterior doors will be provided with concealed access card readers.
- Exterior doors and frames at the Garden Level will be reconstructed as single doors based on the historic wood paneled design, with transom [Figure 6.4.3.53], and will have ADA power assist mechanisms.
- 2 Historic window openings at the Garden Level that were converted to door openings will be fitted with windows.
- 4 Historic window openings at the Second and Third Floors that currently contain egress doors connecting to the exterior fire escape will be restored as windows.
- The door at the west entry stair cheekwall on the North Elevation will be replaced with a 2 1/4" wood paneled door.

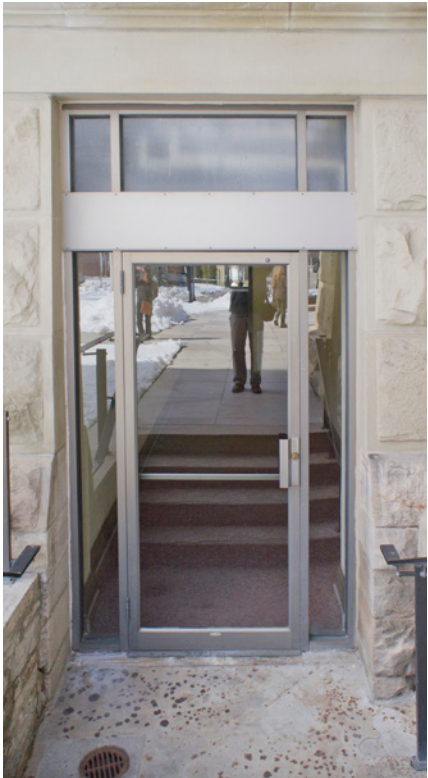
Figure 6.4.3.52: Garden Level Door B53-1 with Replacement 'Storefront' Door, Sidelights and Frame.

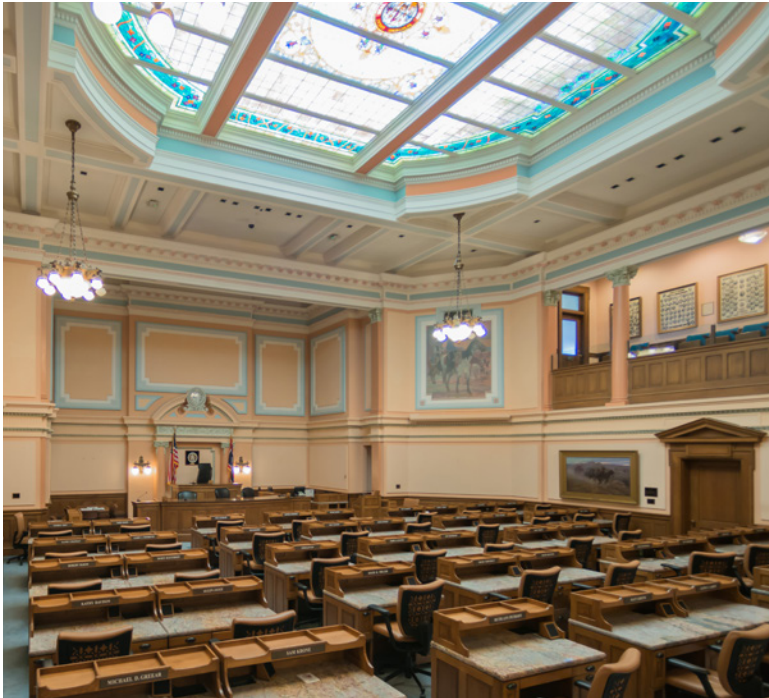
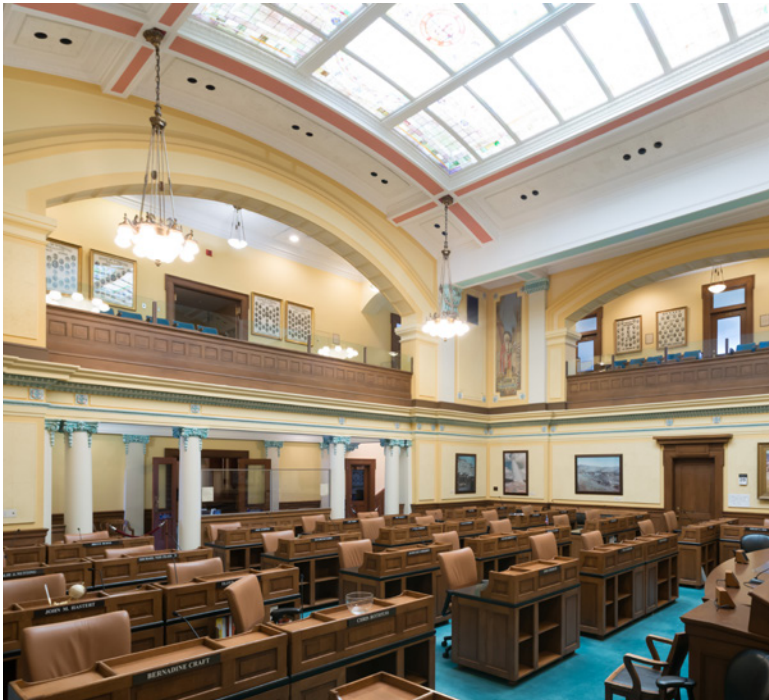
Figure 6.5.3.5: View of House Chamber Looking Southeast

The House and Senate Chambers are generally in excellent condition.

- Clean/repair laylights [Figure 6.5.3.5 and Figure 6.5.3.6].
- Remove acoustic tile; repair plaster ceilings.
- Repair all historic 3D plaster and decorative wood elements, such as cornices, brackets, and beam enclosures.
- Paint with historic colors, stenciling and patterns/effects identified in the Paint Exposures Program.

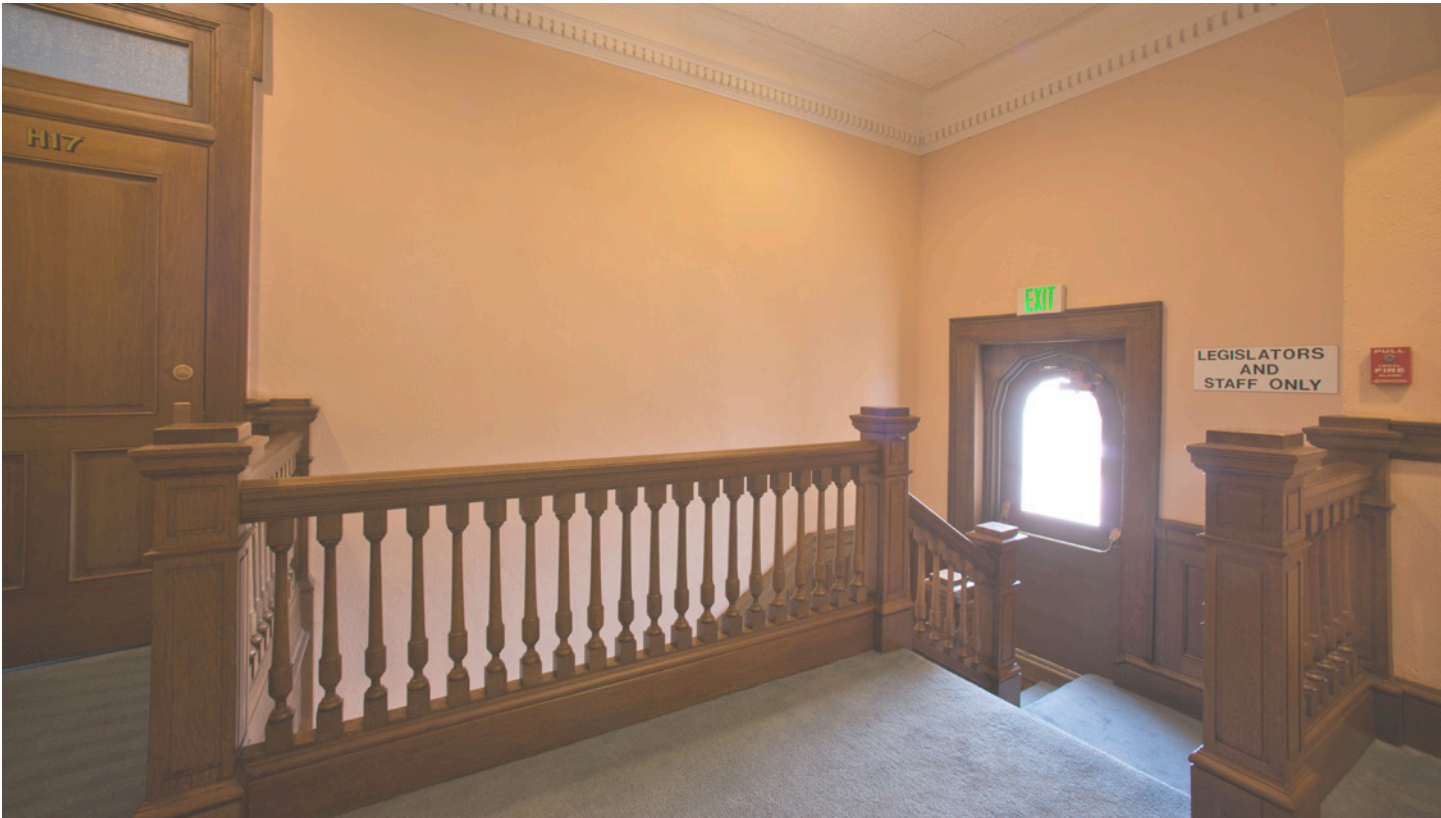
Figure 6.5.3.8: House Chamber North Stair at the third floor. North Stairs to be disassembled and re-assembled with code compliant treads and risers.

- Limited repair and re-finishing to match existing balusters, railings and base. Clean. Re-seal. [Figure 6.5.3.7 and Figure 6.5.3.8]
- Remove glass guardrails at balconies and dividers at rear of House and Senate Chambers. Provide new glass guardrails at code-compliant height balconies to supplement existing historic rails to remain.

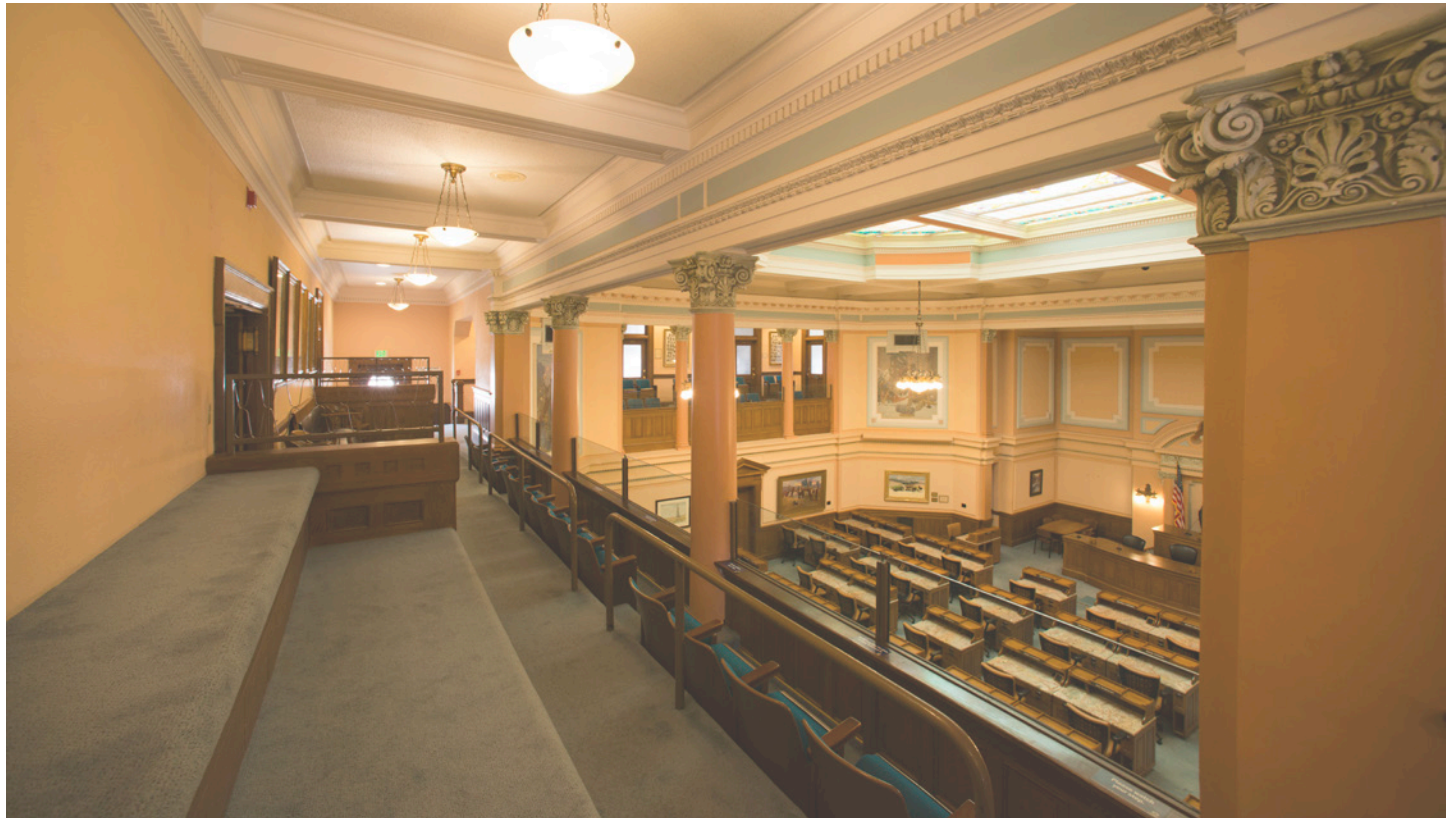
Figure 6.5.3.11: House Chamber West Balcony. Note existing glass panels above balcony rail along column line.

- Remove non-historic seating. Provide new fixed seating in period design with leather upholstery [Figure 6.5.3.11].
- Remove existing carpet. Repair substrate. Provide custom carpet.

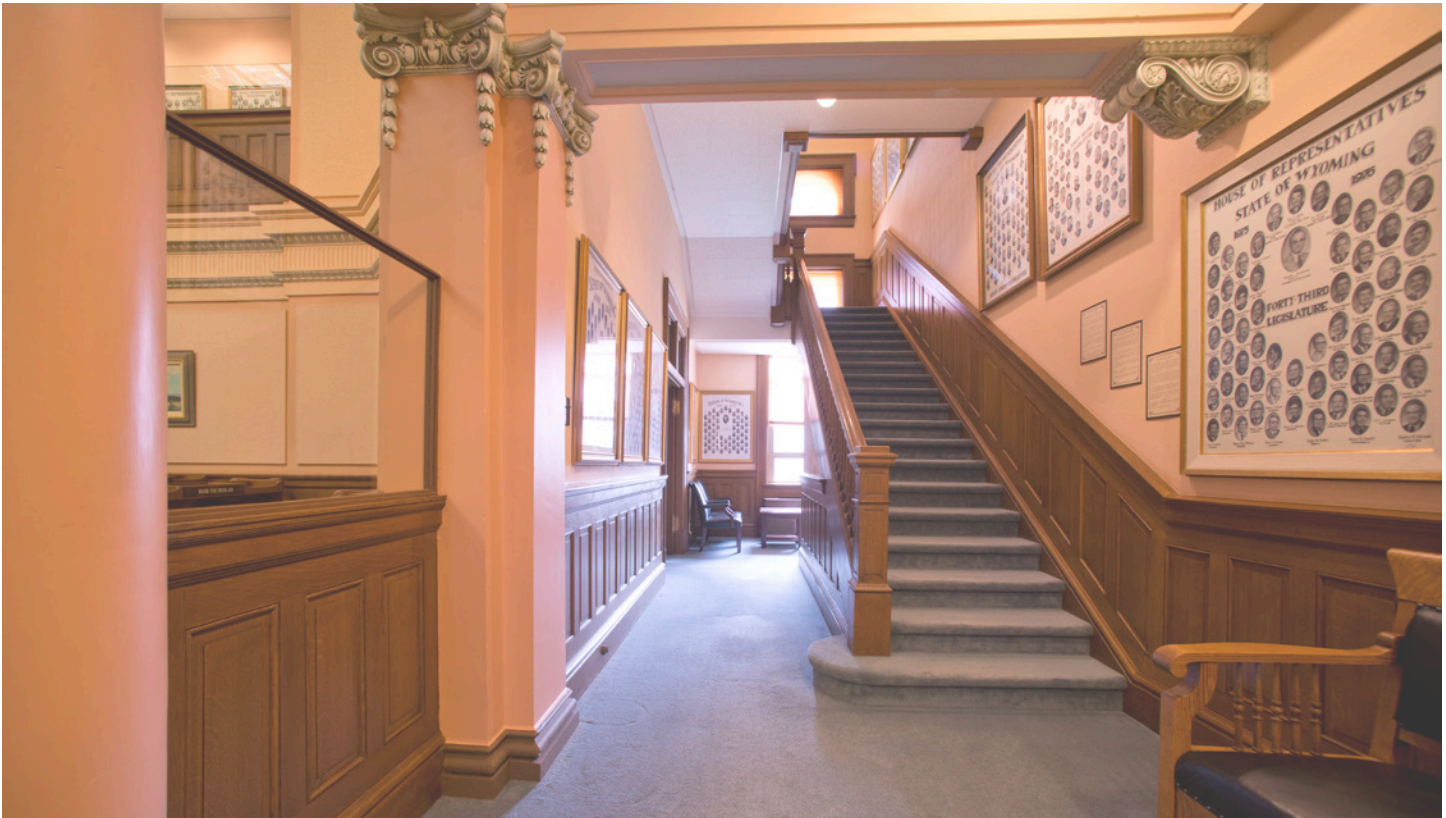
Figure 6.5.3.12: House Chamber South Stair at the Second Floor. Note existing glass panel above waist-high partition between hall and Chamber proper.

- South Stairs: Limited repair and re-finishing of balusters, railings, treads, risers, and stringers to match existing. Clean. Re-seal. [Figure 6.5.3.12]
- North Stairs: Disassemble stairs, wainscot, and closet enclosure below. Reassemble/rehabilitate with code compliant riser and tread dimensions. Provide new wood elements

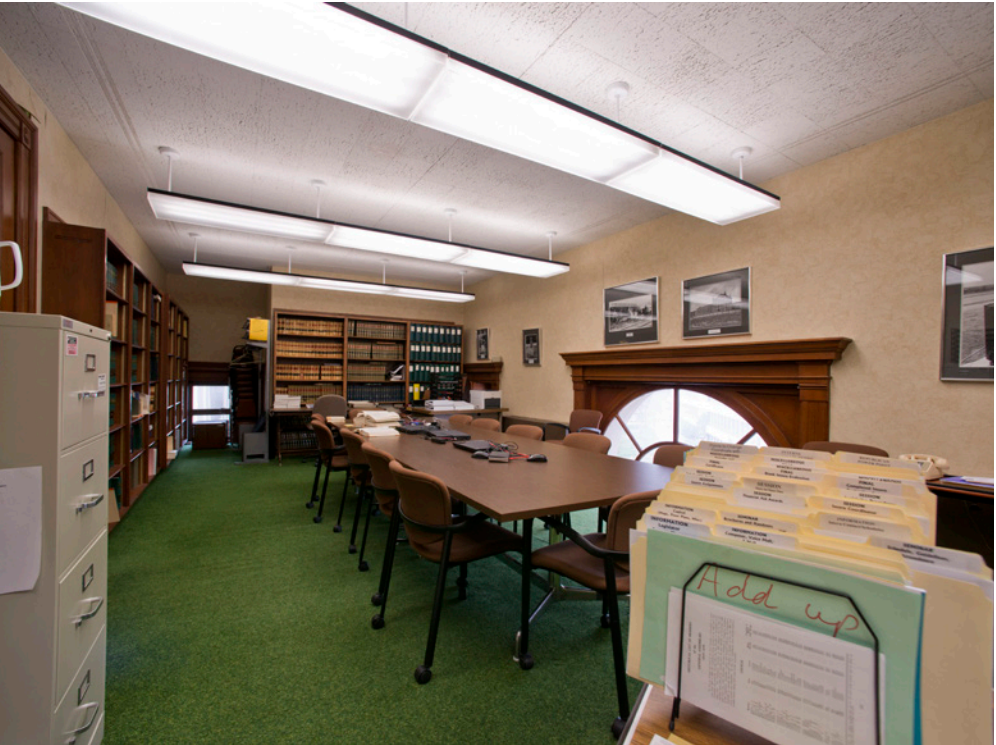
Figure 6.5.4.7: Legislative Services Office, Room 308

The existing Committee Rooms are generally in very good condition. However, there is a need to increase their number. Legislative Services Offices (LSO) on the Third Floor, north of the Rotunda, is in good condition, but needs considerable modification to transform it into a Committee Room [Figure 6.5.4.7].

- Remove acoustic tile affixed to walls.
- Repair plaster on historic masonry walls.
- Remove all partitions within new Third Floor Committee Room 303, north of Rotunda and partition at north of Room 205, second floor, north of Rotunda.

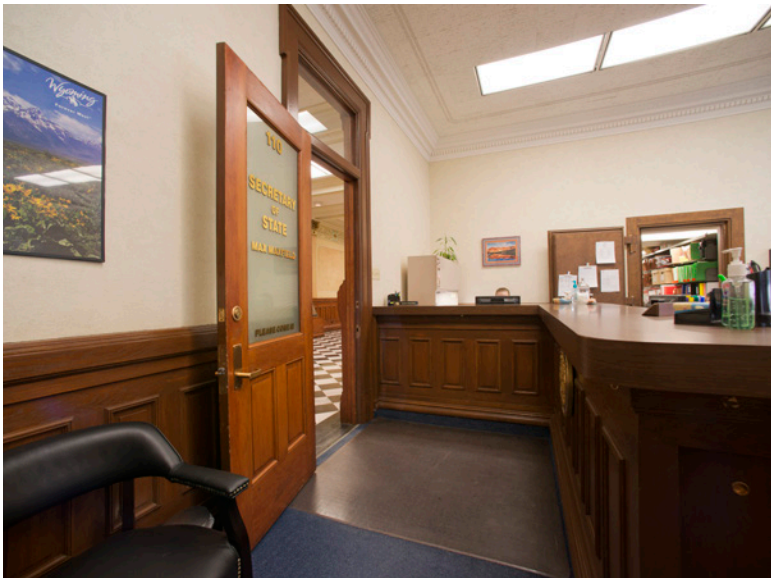
Figure 6.5.6.6: Room 110 in 1917 Section of the Capitol. Note signage painted on glass lite.

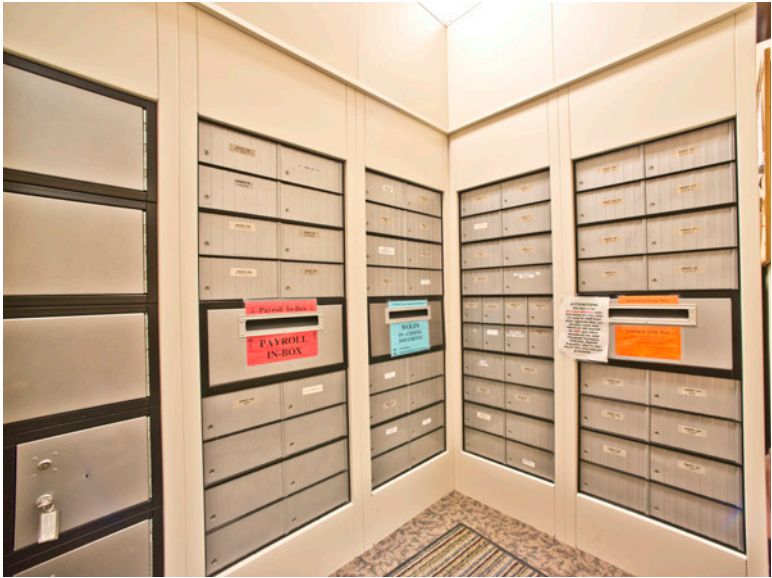
Figure 6.5.7.5: Mail Room adjacent to elevator and the western Monumental Corridor on the first floor.

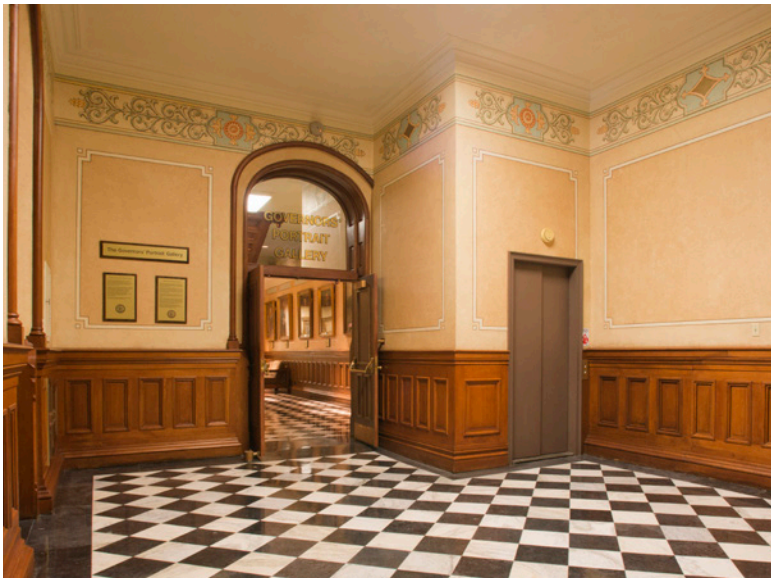
- Restrooms are inadequate in number and difficult for visitors to find. There are too few ADA-compliant restrooms.
- Two elevators and a handicapped lift block the Monumental Corridors.
- There are no electrical rooms in the building. Electrical panels are located throughout.

Figure 6.5.7.6: Elevator obstructing a historic door in the eastern Monumental Corridor on the first floor.

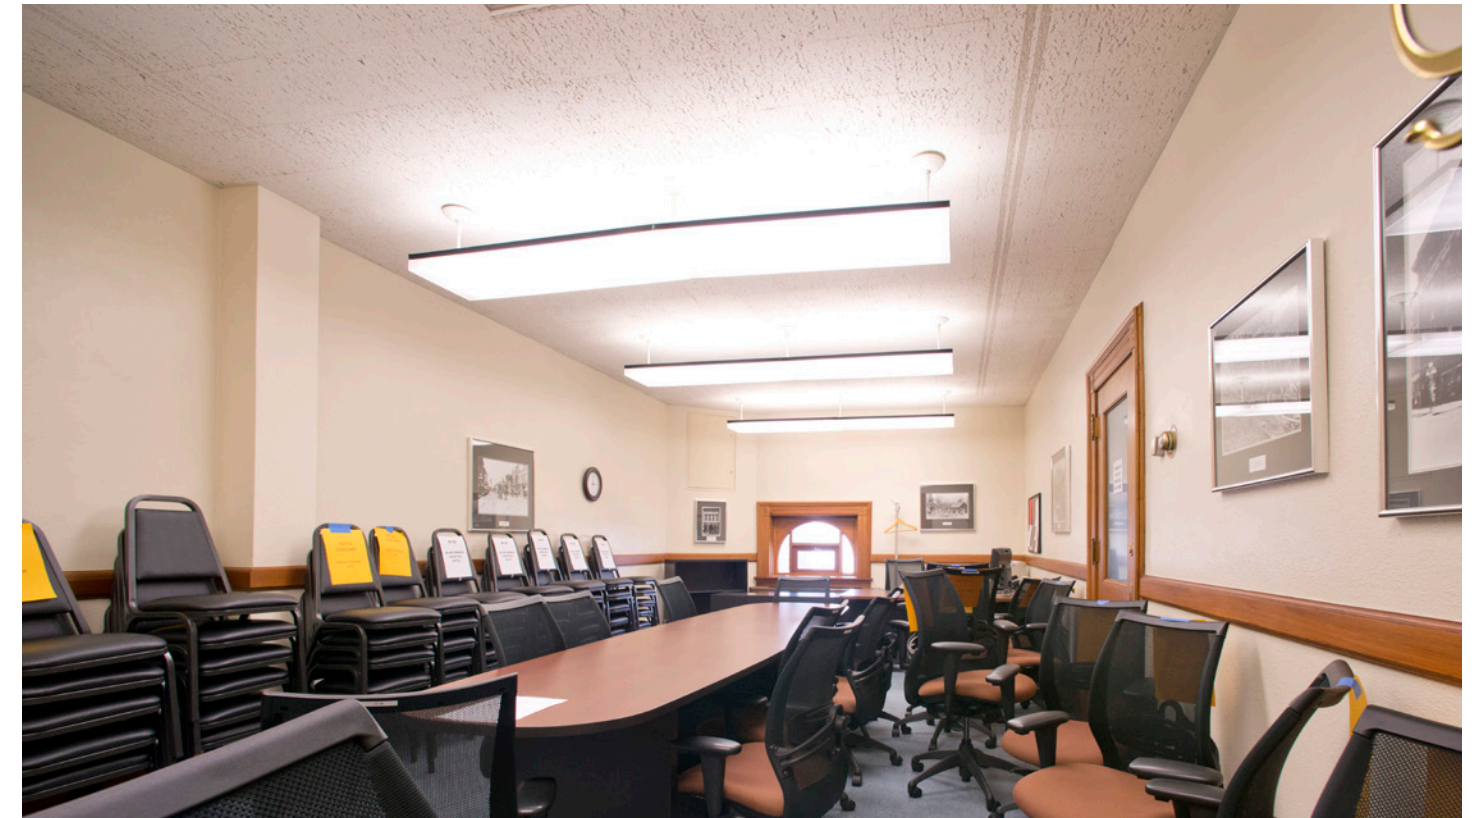
Figure 6.5.7.10: Under-utilized Space of Room H18 on the Third Floor.

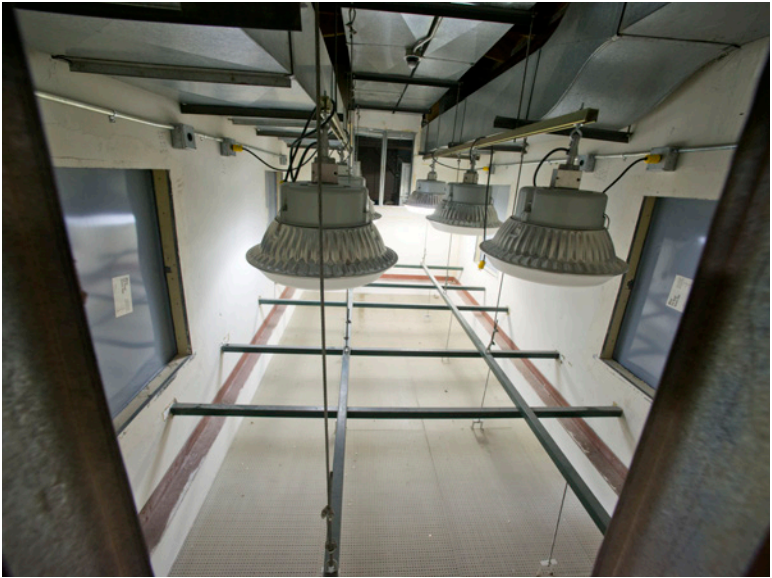
Figure 6.5.9.3: View from above of Laylights and Lights in Third Floor Ceiling above Monumental Stairs. Note solid ceiling above rather than historic skylight.

- Light monitors above the Monumental Stairs are roofed over and, as such, are a lost opportunity to admit natural light [Figure 6.5.9.3].

- Replace 1890 girders with shallower members to provide space for and access to mechanical units.
- Provide new skylights above the laylights at the Monumental Stairs.
- Provide new laylight enclosures below the location of the 1890 Chambers' skylights to provide a route to exhaust smoke out of building through new roof hatches, as part of the Smoke Exhaust System.
- Remove ceilings from office area.

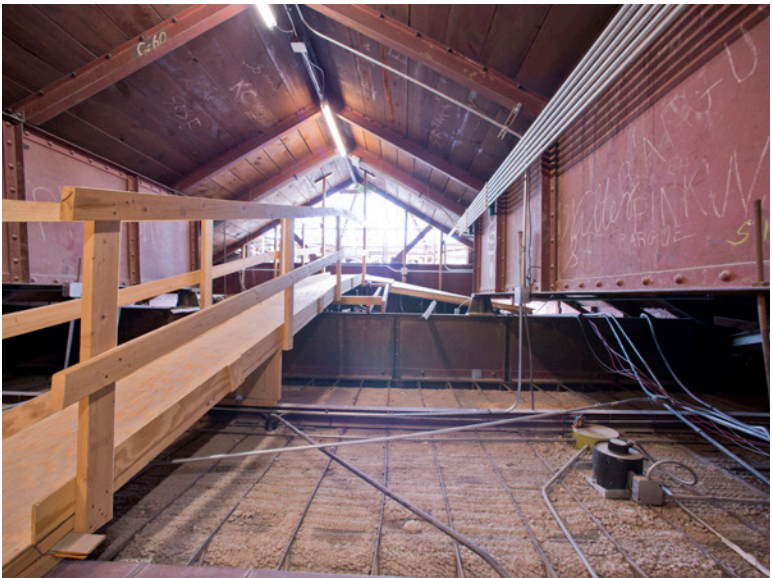
Figure 6.5.9.5: Wooden Catwalks in Attic. Note unprotected ceiling and 1890 girders to suspend former 1890 Chambers' balcony. Girders divide up space, make access to all areas difficult, and prevent efficient space utilization.

- Access in much of the Attic is via wooden catwalks that do not appear to have been engineered [Figure 6.5.9.5].
- Large areas of the existing ceilings are exposed to potential mechanical damage from above [Figure 6.5.9.7].

- Large girders in the 1890 section were designed to hang the 1890 House and Senate Chambers Balconies. The girders are over-sized for their current function of supporting the roof and prevent the 1890 portion of the Attic from being more useful as a building services space [Figure 6.5.9.5].

- Above the House and Senate Chambers, provide new catwalks and rolling scaffold to access the laylights located to not cast shadows on the House and Senate Chambers laylights.
- Provide "bathtubs" with water sensors under all mechanical equipment to collect and sense leaks to protect historic fabric on levels below.
- Provide new engineered steel catwalks throughout to provide access to serve all equipment in Attic. Provide wood raised floor over 1888 section.
- Remove all carpet.
- Repair floors as required.

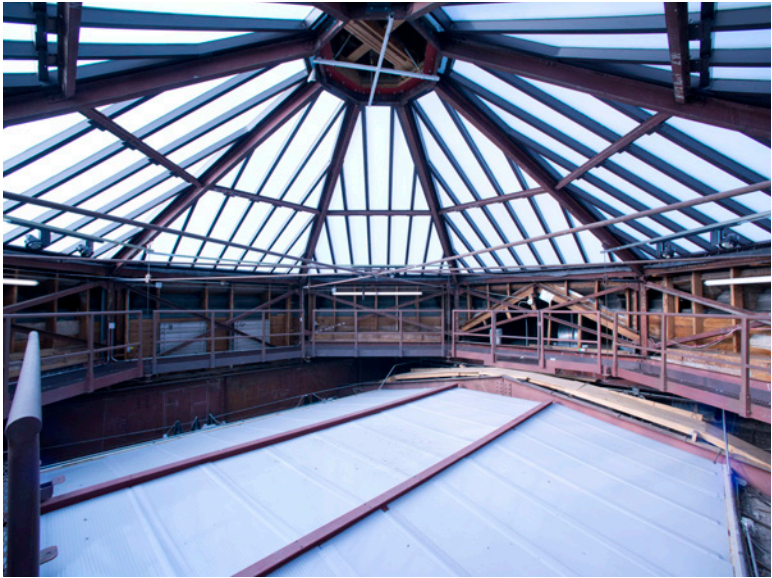
Figure 6.5.9.6: Chamber Skylight as Viewed from Attic. Note light-diffusing panel above laylight below.

- Remove existing lighting.
- Replace protective light-diffusing panel above the House and Senate Chambers laylights.
- Provide lighting at laylights at House and Senate Chambers, Rotunda, and Monumental Stairs, and at laylights below smoke exhaust hatches above Monumental Corridors, east and west, 1890 section.
- Provide utility lighting throughout.
- Refer to Lighting Section 6.5.14 for detailed treatment of lighting.

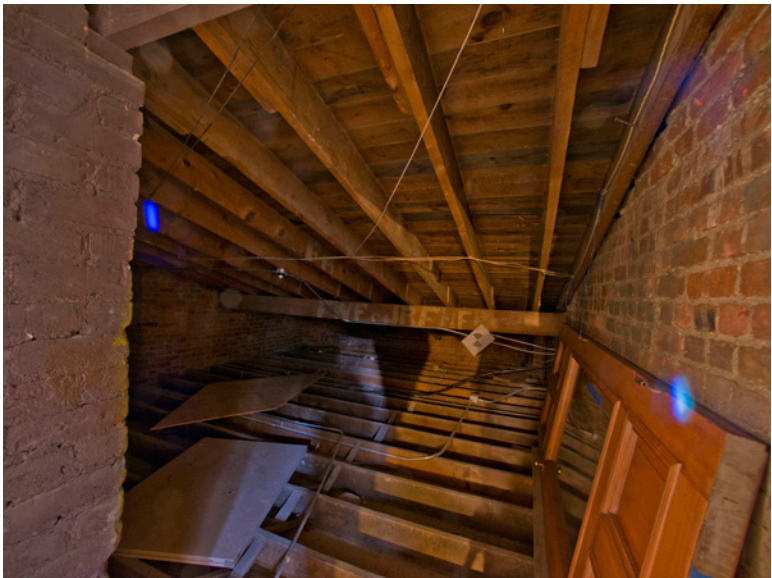
Figure 6.5.9.7: Attic. Note no protection is provided for ceiling below.

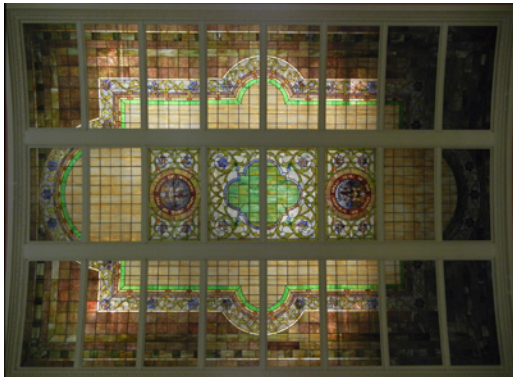
Figure 6.5.9.9: House Chamber Laylight. Note shadows cast by catwalks and rolling scaffolds above.

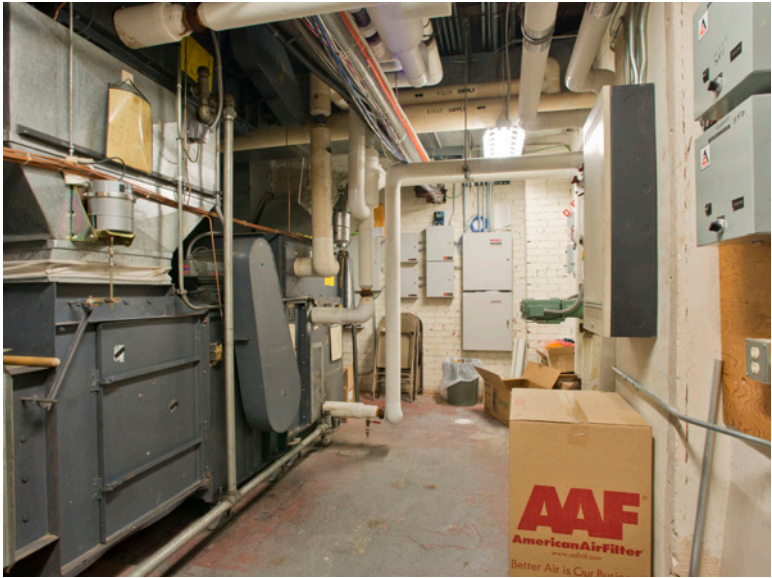
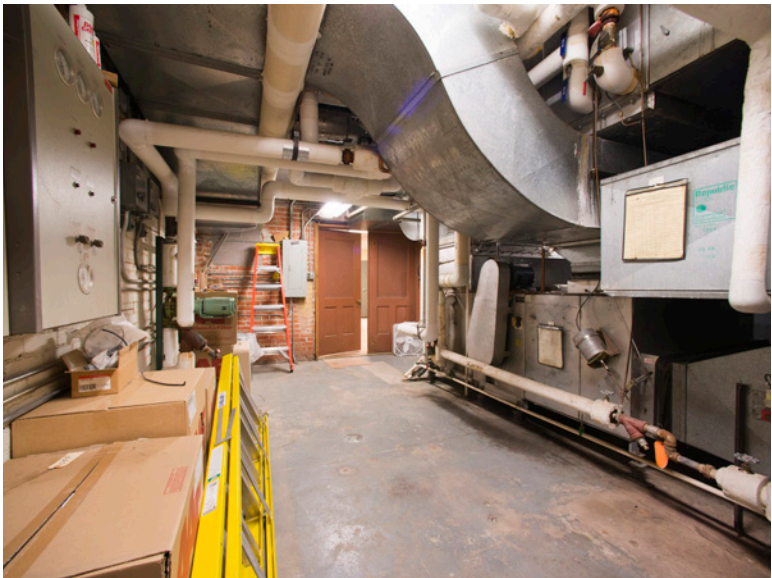
- Two areas of the Garden Level are specifically dedicated to housing building services, such as mechanical equipment: Rooms B81 and B36.4. They are currently unfinished spaces that are recommended to be finished spaces serving as part of new office suites [Figure 6.5.10.5, Figure 6.5.10.6, Figure 6.5.12.2].

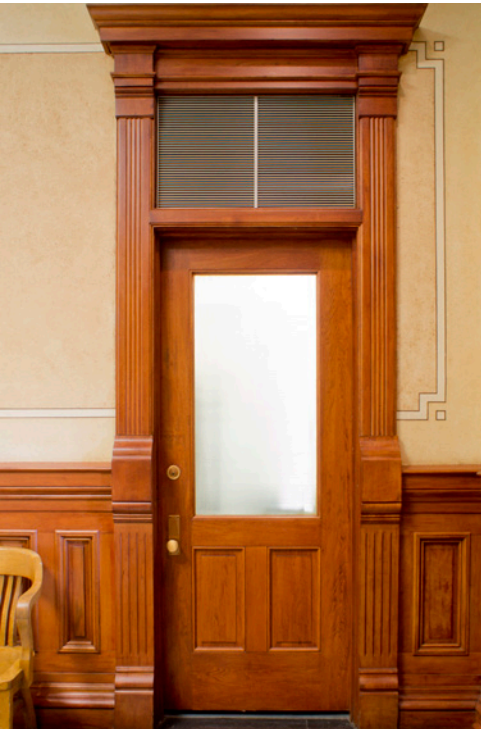
Figure 6.5.11.7: Door 111a is Typical of those with Rectangular Transoms in Public Spaces on the First Floor from the Phase III (1917) Period of Construction.

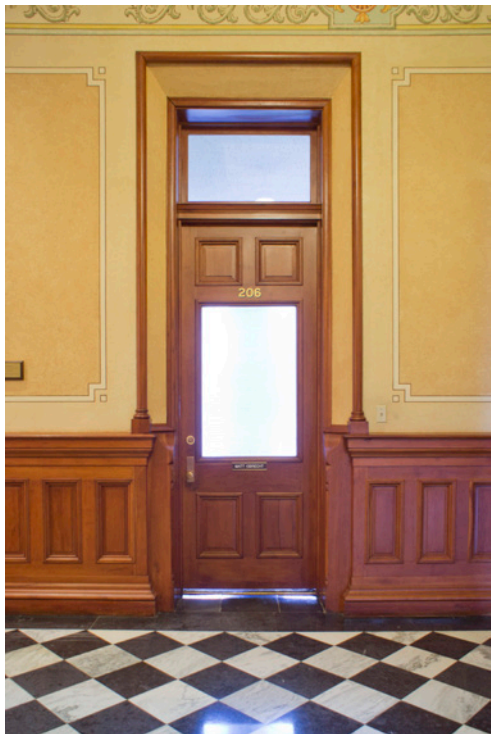
Figure 6.5.11.8: Door 206a is Typical of those with Rectangular Transoms in Public Spaces on the Second Floor from the Phase I and II (1888 & 1890) Periods of Construction.

- All second floor doors have rectangular transoms.
- Although the historic drawings indicate glass at the majority of the doors, many glass panels have been replaced with wood panels.
- Some historic wavy glass panels exist, but many of the doors have flat glass panes, or glass that is textured to obscure view.
- Paired doors into spaces north and south of the Rotunda have large double action hinges.

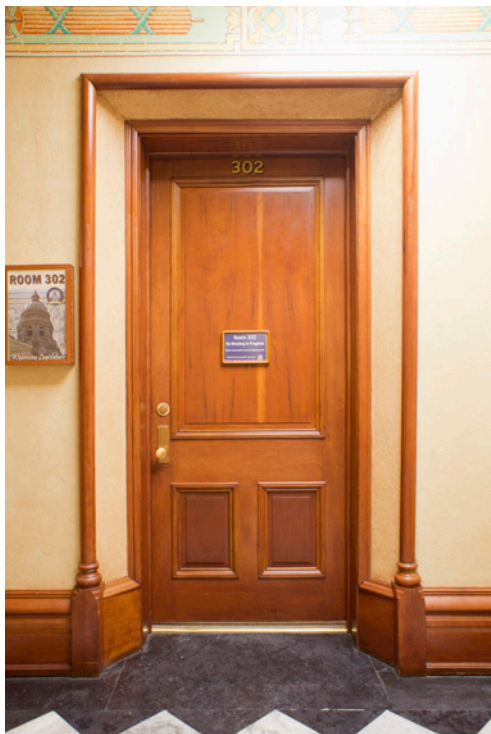
Figure 6.5.11.9: Door 302a is typical of doors in public spaces on the Third Floor from the Phase I and II periods of construction.

- the same splayed jambs and bold wood bead, but transoms are absent and the doors are not as tall.
- The wood bead extends to a plinth block at the wood base at the floor instead of terminating at a chair rail.
- Many of the historic clear glass panels on doors facing public spaces are replaced with textured glass.

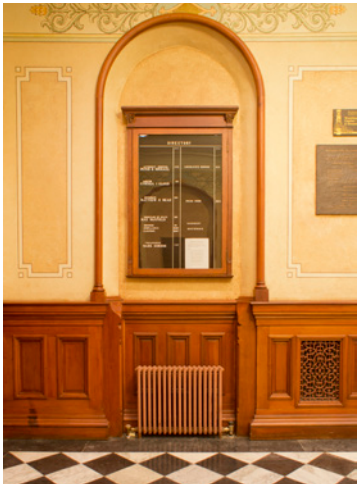
Figure 6.5.11.10: No Longer Existing Door 105a Will be Reconstructed Based on Historic Profiles and Reinstalled at the Restored Opening.

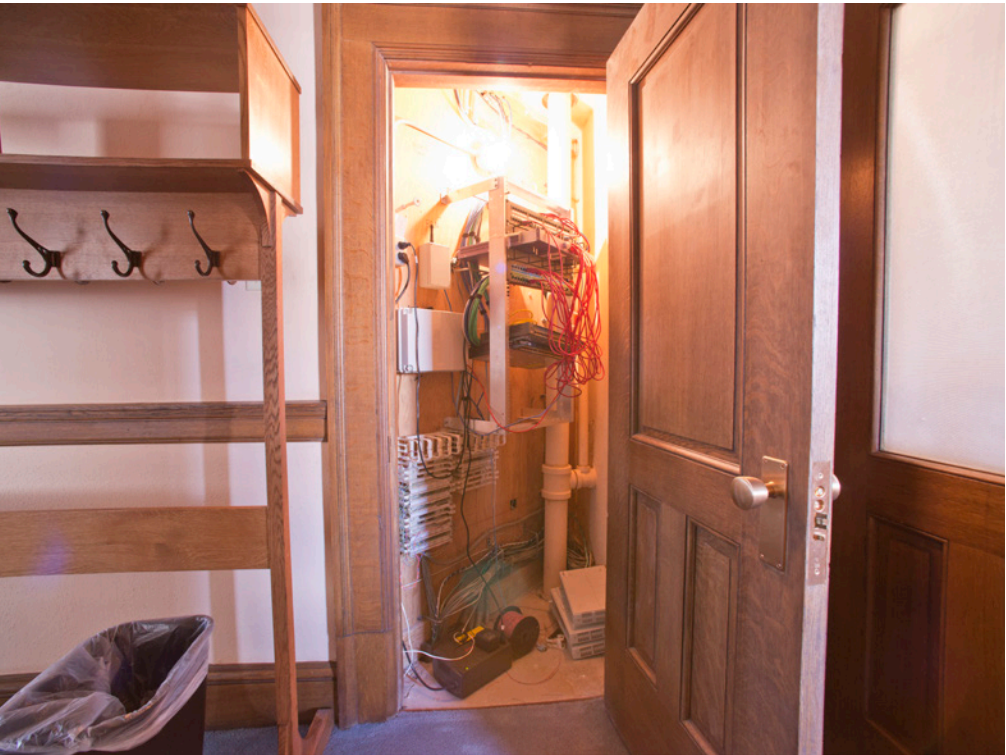
Figure 6.5.12.1: Room H-7

- Bulky fan coil units and associated piping are located in the offices, and some piping is exposed.
- HVAC units in the Garden Level and Attic provide central air conditioning to select areas only; window units serve other areas [Figure 6.5.12.2].
- There are no electrical rooms in the Capitol proper. Panels are randomly located in the building [Figure 6.5.12.1].
- Ceilings are lowered below window heads to accommodate duct work [Figure 6.5.12.3].

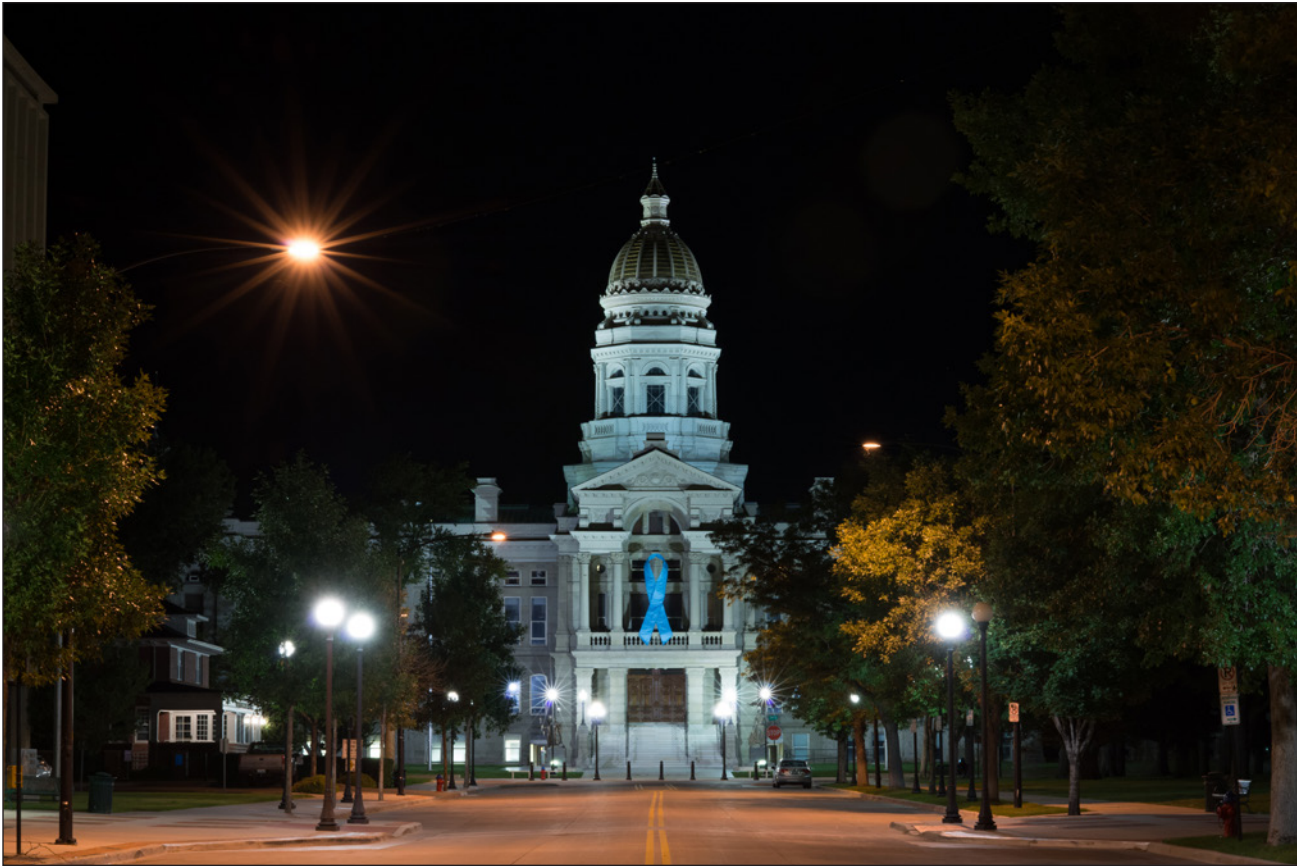
Lighting quality, in terms of brightness patterns, color of light, and color rendering properties, is inconsistent and generally below both restoration and commercial standards. For example, the architectural design and quality of materials and craftsmanship are not well-rendered under the current lighting conditions [Figure 6.5.14.1].

Figure 6.5.14.1: The existing facade and dome lighting introduce an unflattering wash of poor-color cold light.
